Manhole Inspection Summary

Manhole # S31EE_038MH

Insp Date: **1/24/07 1:09 PM**

Location Address: **231 29TH DIVISION ST**

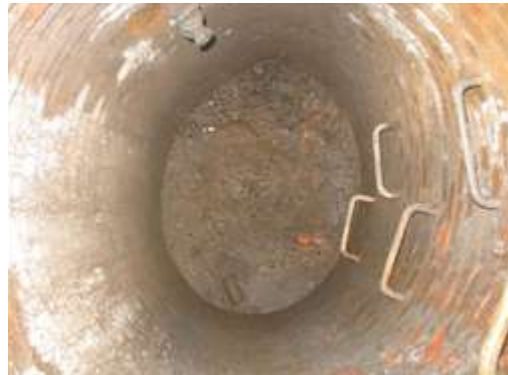
Top View

Channel debris.

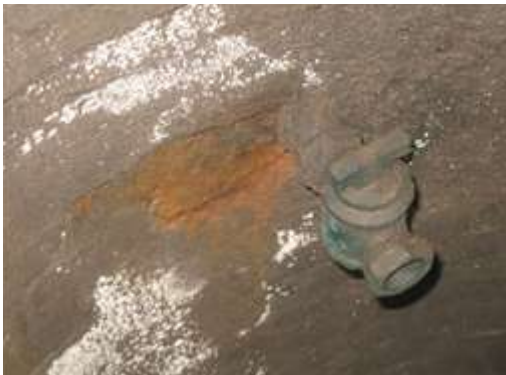
Faucet coming into the MH

Source of infiltration.

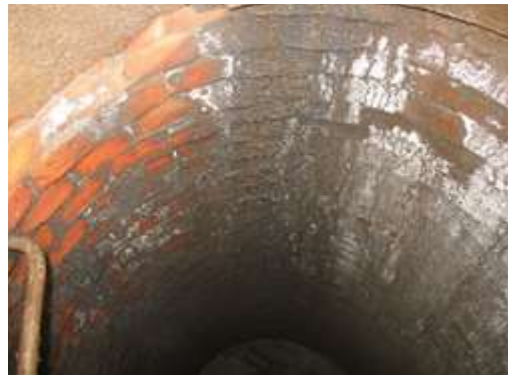
Defect

☒ **Leaks**

Infiltration: ☐ None ☒ **Joint** ☐ Cracks ☐ Mortar ☐ Roots ☒ **Wall**

Infiltration: ☐ None ☐ Joint ☐ Cracks ☒ **Mortar** ☐ Roots ☒ **Wall**

Frame leaks. Adjustment and Corbel infiltration.

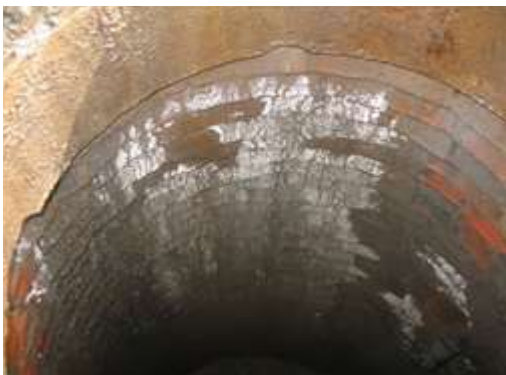
Defect

☒ **Cracked**

Frame leaks. Cracked frame. Adjustment infiltration.

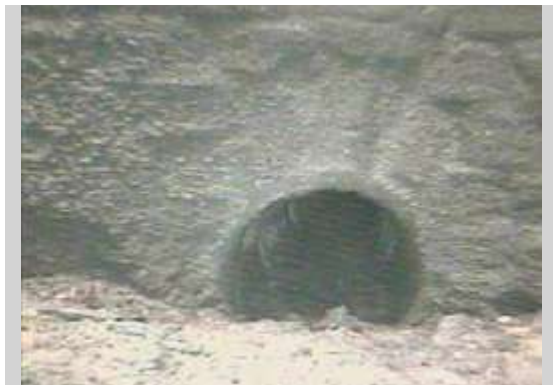
Pipe Out @ 12 O'Clock

Deposits: ☐ None ☒ **Mud** ☐ Sludge ☒ **Debris** ☒ **Grease**

Silt Depth: **1** (in.)

Deposits Extent: **Light**
